# SEALANT CONTINUITY - AND INCLUDING SECONDARY SEALS

CURTAINWALL / STOREFRONT - SEALANT CONTINUITY AND INCLUDING SECONDARY SEALS

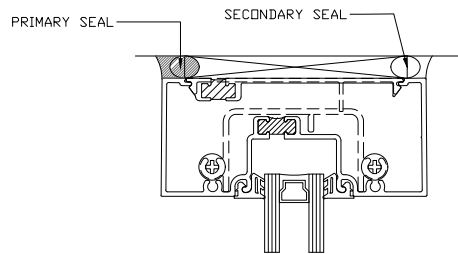
TUBELITE EXAMPLE HEAD DETAIL

Note the details on the right show the primary sealant line at 2-3/16" from the face of the frame. This will vary across systems, and manufacturers, but make sure you are consistent where you show it, and that it matches the standard details from the manufacturer.

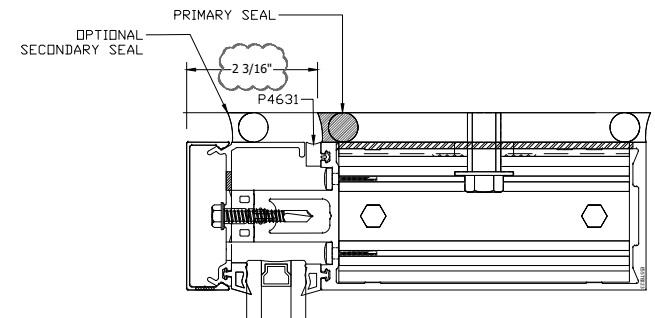
TUBELITE EXAMPLE HEAD DETAIL

When looking at storefront typically there are only two lines of sealant. An exterior "primary sealant" and an interior "secondary sealant". Like curtainwall the exterior seal shown at the face of the frame must "marry" consistently around the frame in order to manage leaks.

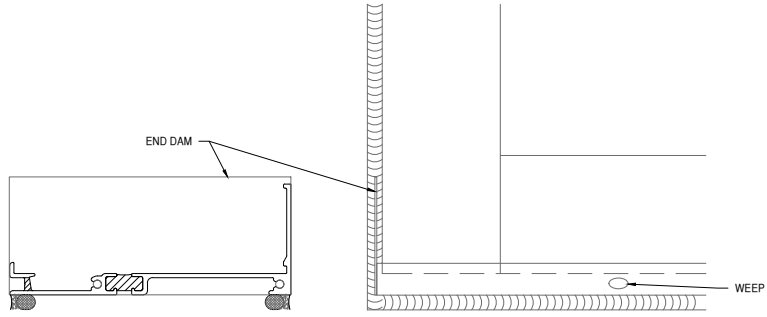
END DAM INTERACTION WITH JOINT

FOR CURTAIN WALL THE WATER CONTROL IS PART OF ALL THE HORIZONTAL MEMBERS THAT GET WEEPS, BUT FOR STOREFRONT THE WATER IS MEANT TO RUN DOWN THE VERTICALS TILL IT GETS TO THE SUBSILL, WHERE IT IS WEEPED OUT. TO THE RIGHT YOU CAN SEE HOW THE SUBSILL AND END DAM INTERACTS WITH THE JOINT.

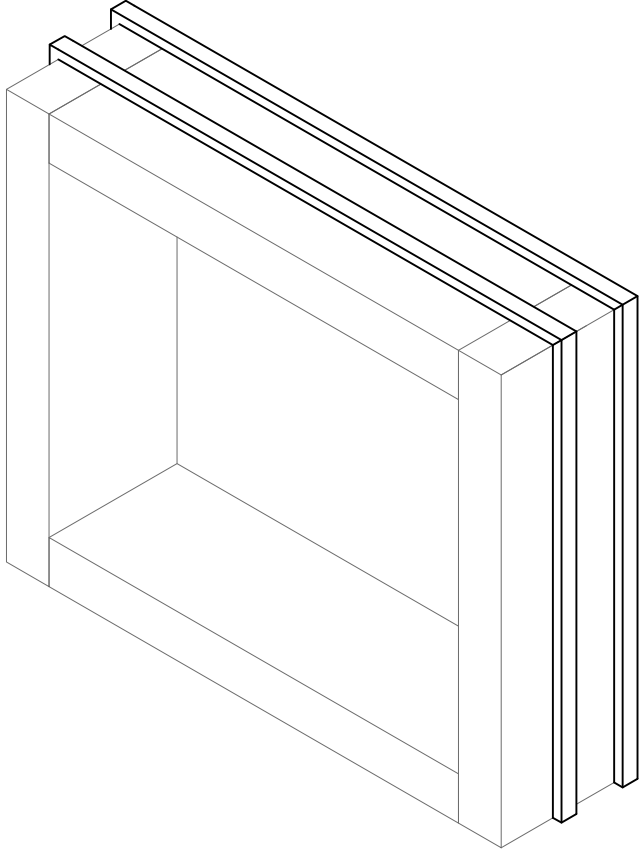
FRAME JOINTS WITH CONTINUOUS JOINT

THIS CONTINUITY CAN BE SEEN BELOW WITH THE LEFT HAVING A CONTINUOUS JOINT, BUT THE RIGHT HAS THE FRONT JOINT MISMATCHED. THE HEAD AND JAMB ARE NOT ALIGNED.

THIS CONTINUITY IS IMPORTANT FOR WATER CONTROL. ITS LOCATION IN RELATION TO THE SYSTEM IS DESIGNED TO BE BEHIND THE WATERLINE OF THE SYSTEM, WITH THE POINT BEING THAT NO WATER SHOULD GET PAST THE PRIMARY SEAL.

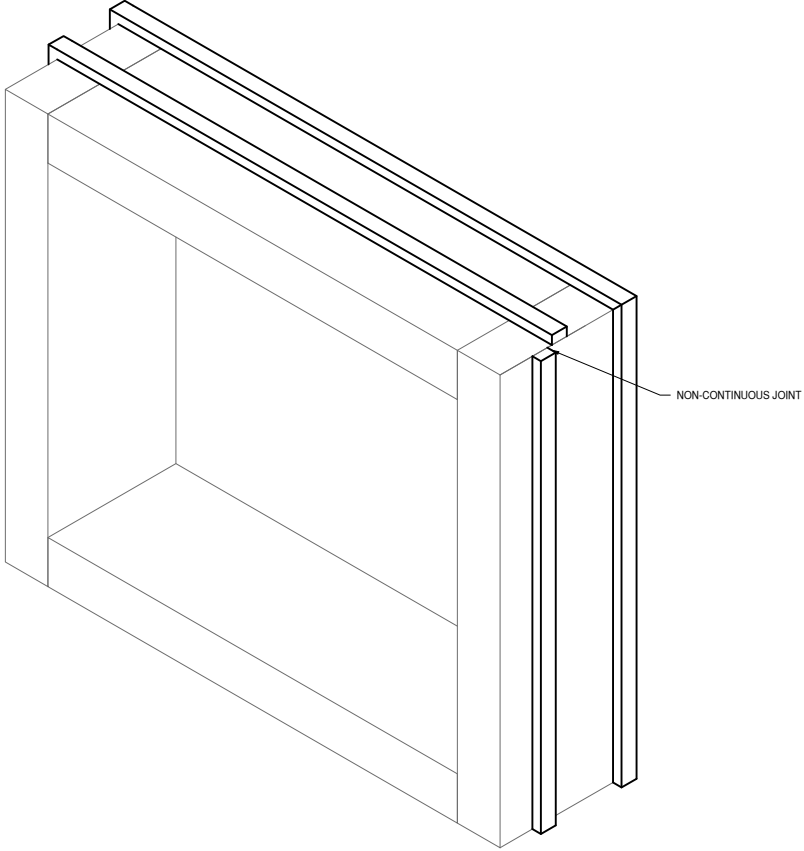
FRAME JOINTS WITH MISMATCHED JOINT

THIS IS BAD PRACTICE, BUT THERE ARE SOME SITUATIONS THAT LINING THEM UP IS NOT POSSIBLE. IN THIS CASE THE INSTALLER CAN BRIDGE THE DIFFERENCE WITH MORE SEALANT.

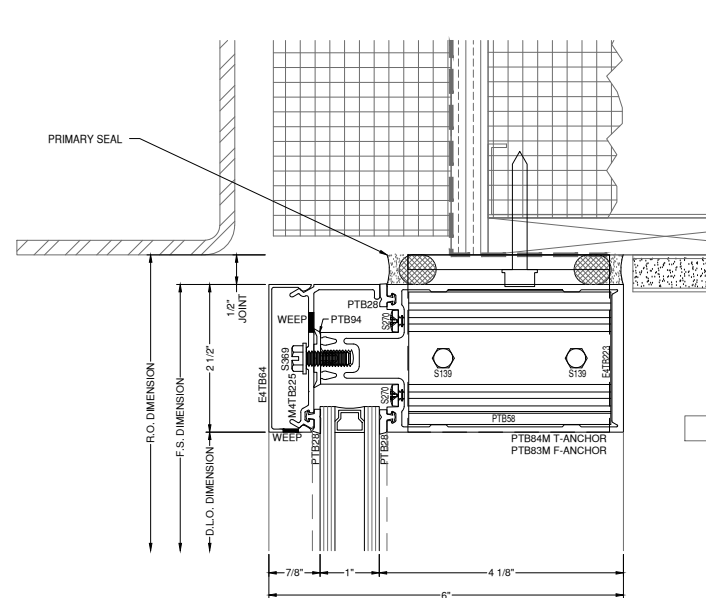
In the event that the location of the system against the condition does not allow the primary seal to rest against the membrane or other building water managing material there are some options to fix this without moving the system.

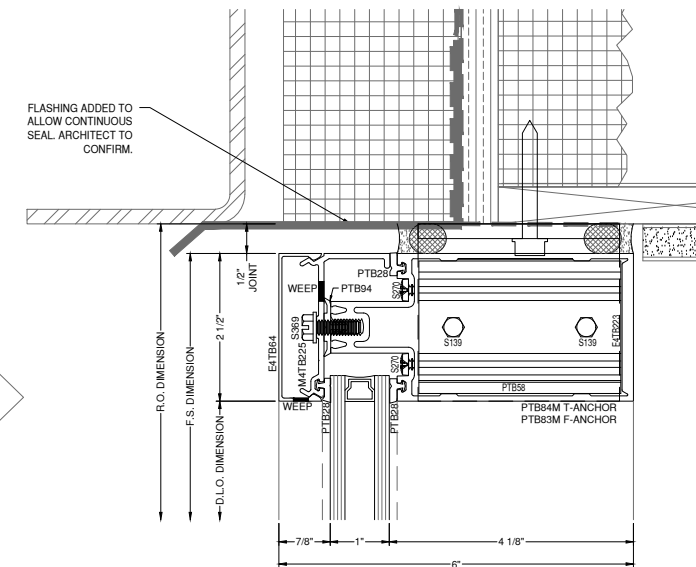
One possible solution is the addition of flashing that ties into the building membrane that can be sealed against.
